EXCESS EROSION AND DEPOSITION IN THE CATCHMENTS OF KAMENICHKA AND RADANJSKA RIVER-REPUBLIC OF MACEDONIA

Abstract: One of the greatest environmental problems in the Republic of Macedonia is accelerated soil erosion caused by high human impact during last centuries on to the susceptible landscape. Natural factors itself are very suitable for development of such erosion: from mostly erodible rocks and soils on the mountainous slopes around the depressions, to the generally continental, semi-arid climate and slight vegetation cover. Because of that, there are sites with severe erosion and deposition like those in the catchments of Kamenichka River and Radanjska River, two torrential tributaries of Bregalnica. In these catchments there are varieties of erosion-related landforms: rills, gullies, badlands, landslides, as well as valley-type alluvial fans and huge alluvial plains. Such devastating accelerated erosion and deposition largely transformed original landscape, and represent significant environmental, social, and economic problem in local areas. Because of that, some measures of protection and conservation were taken from 1950-ties in both catchments. But it is obvious that the

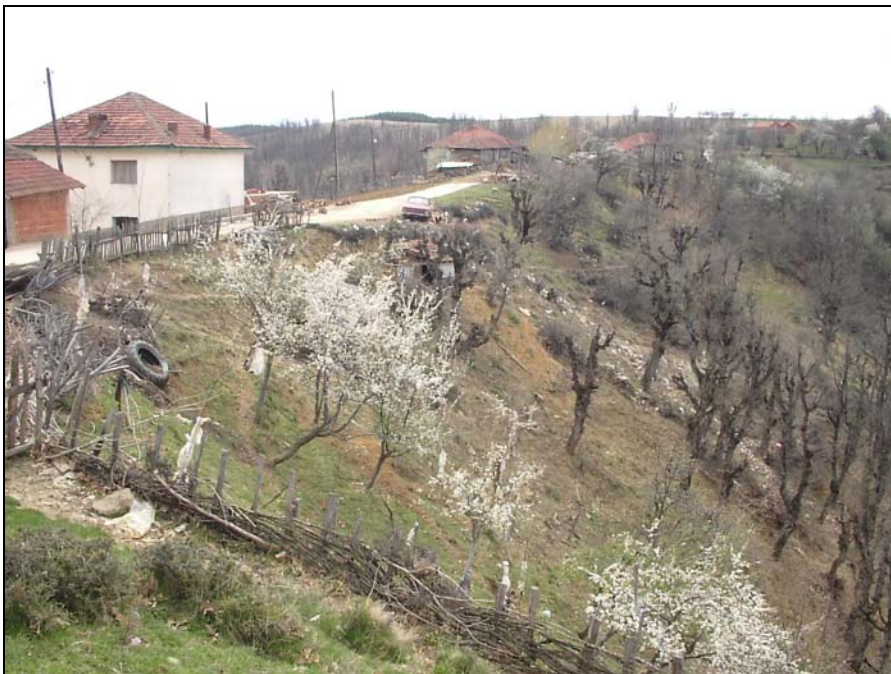
Landslides are also very common in this area, especially in the lower parts of the catchment, below 1200 m altitude. Their formation is enabled with soft sediment rocks (sands, sandstones) covering inclined Pliocene clay layer. However, the main trigger is large anthropogenic influence which changed overland flow, increased slopes etc. Numerous landslides are recorded downstream from the village Sasa. This part of the valley is composed by soft erodible schists and clastic sediments, mostly uncovered, eroded and with steep slope. Because of that, soils and decomposed rocks on the valley sides almost entirely slide-down toward the valley bottom, making an enormous system of landslides with total estimated volume of 5 millions m^3 . That is particularly evident near the village Kosevica where the village itself is in danger (fig. 2). Aside of that, several landslides are registered on the coastal region around Kalimanci Lake (Milevski, 2006). All of them highly influence the rate of soil loss and the rate of sediment load from the Bregalnica River to the Kalimanci reservoir. It is worth to stress that some landslides were activated recently with direct human impact, mostly by road incision in unstable terrain.

Figure 2. Large landslide in Kosevica village, endangering near houses and roads.

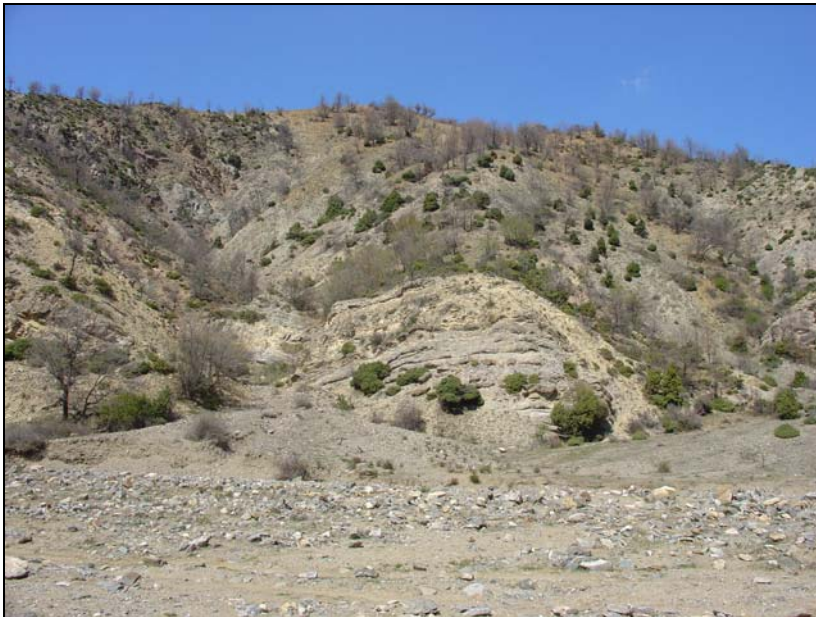
Gullies are the most notable and destructive landforms in the Radanjska River catchment, usually found on the right valley side (Tiken Bair hill). Because the soil layer is already removed, gullies were incised in parent rocks: Precambrian mica-schist, gneiss and Eocene complex (sandstone, limestone etc.). Depending of rock erodibility, they have more or less deepened V-shape with straight or convex sides and with steep, stair-like longitudinal profile. Transversal and longitudinal profile show relatively young, active stage of gully development. Frequently there are smaller gullies on the side of larger ones, which in turn can be really large: up to several hundred meters in length, so it is difficult to distinct them from small torrential catchments.

Figure 3. Rill and gully erosion with alluvial fans on the right (east) valley side of Radanjska River.

approach and connect downslope forming an amphitheatric head, while those on the valley side in bottom are parallel one after other, giving the rubber-like shape of the landscape (Fig. 3). However, gullies produce huge quantity of deposits during torrential events, supplying near accumulative landforms or Radanjska River with sediments.

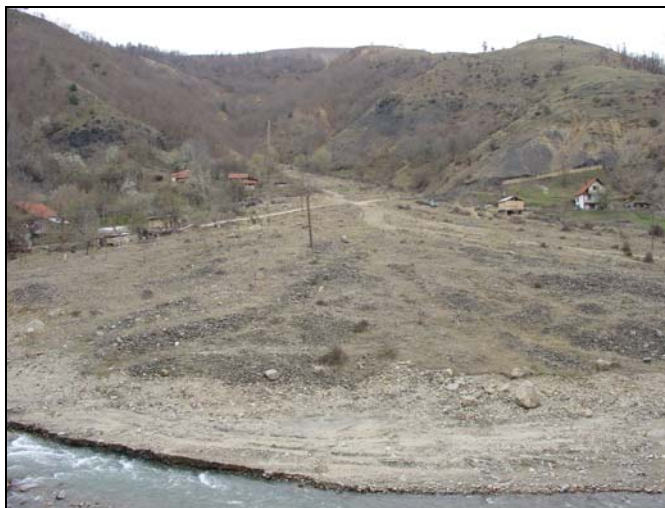
In Kamenichka River most of deposition landforms are along the valley bottom of the Kamenichka River, downstream of the village of Sasa. As a result of excess erosion in the catchment, these parts of valley bottom represent alluvial plain with huge amount of fresh deposits from near torrents and gullies. Along the bottom of the left (east) valley side, these torrents and gullies formed 7 typical alluvial fans which are usually about 200 m wide and 200-250 m long. Each alluvial fan is morphologically well developed with incision channel, intersection point and unstable lateral channels. Deposited material is very coarse, showing short path from the source of origin. Because of permanent rising of the fans from the east, the Kamenichka River itself is moving to west direction, cutting the right valley side (Fig. 4). With regard to the catchment asymmetry, there are few smaller alluvial fans on the right (west) valley side of the Kamenichka River.

Figure 4. Large valley-type alluvial fan in Kamenichka valley from one left torrential tributary.

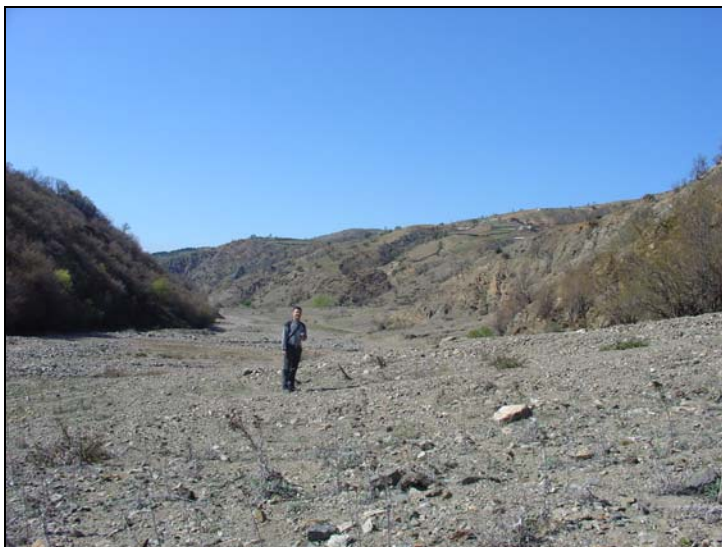
Figure 5. Numerous alluvial fans on the right side and large alluvial plain in the valley bottom of Radanjska River.

Along a right (east) side of Radanjska valley bottom, torrential tributaries and gullies formed a 6 km long series of relatively small alluvial fans. These alluvial fans have typical conic-fan structure, and were created where torrents sharply change longitudinal

slope: from steep upstream slope into flat valley bottom. From more than 30 registered alluvial fans, near 20 has area greater of 500 m², with the largest of about 35.000 m².
